Use of RPAS (Drones) for the Inspection of Century-Old Metal Structures: Example of Application on the Requejo Bridge

Rodríguez Elizalde, Rubén (*)

This article presents a technical analysis of the Requejo Bridge, an outstanding example of metallic engineering spanning the Duero River in Zamora, Spain.

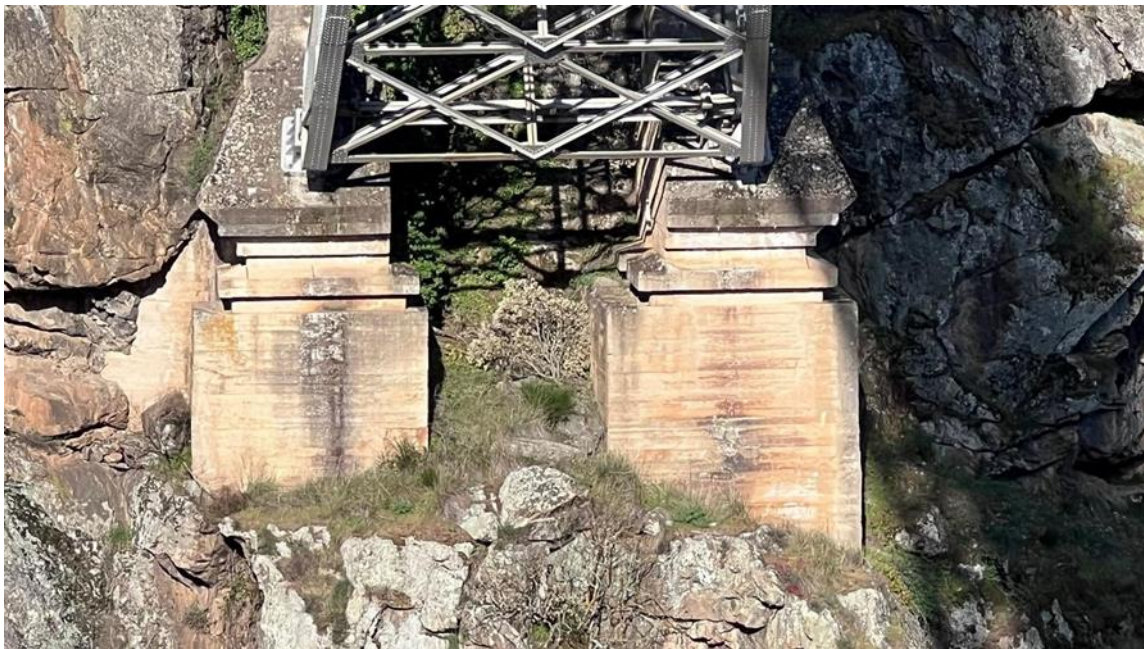
Fig. 8. Arch supports on direct concrete foundations in the area of the second abutment (photograph by the author, taken with a drone).

It has already been observed (Fig. 8) that, despite their centenary age, concrete foundation elements generally presented a acceptable state of conservation, with some slight deterioration related to the durability of the material and especially to the runoff water. The action of runoff water was also the main injury observed on the abutment walls, where marks linked to dampness caused by the continuous process of surface runoff as it slipped down the wall

The articulated supports of the arch were in an excellent state of preservation, both the joints and the anchors. On the other hand, the roller supports of the board presented corrosion in the support plates, but the rollers did not show any notable deterioration, except for some slight corrosion in the body of some of them.

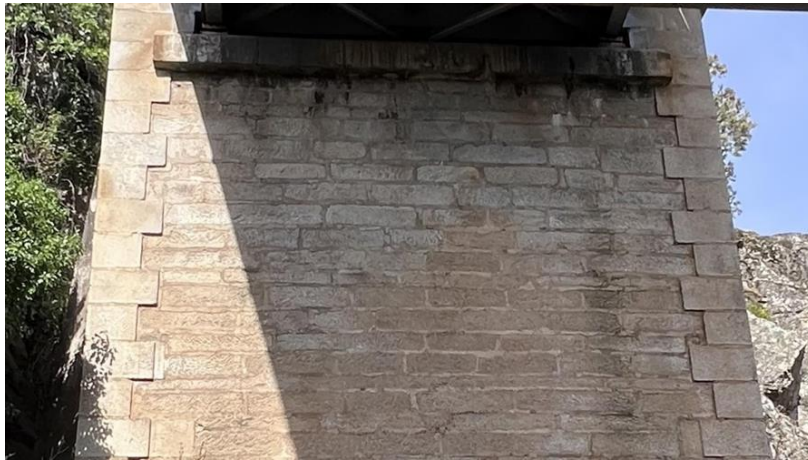
face were discovered (Fig. 12).

Fig. 12. Face of the second abutment, with traces of runoff water (photograph by the author, taken with a drone).

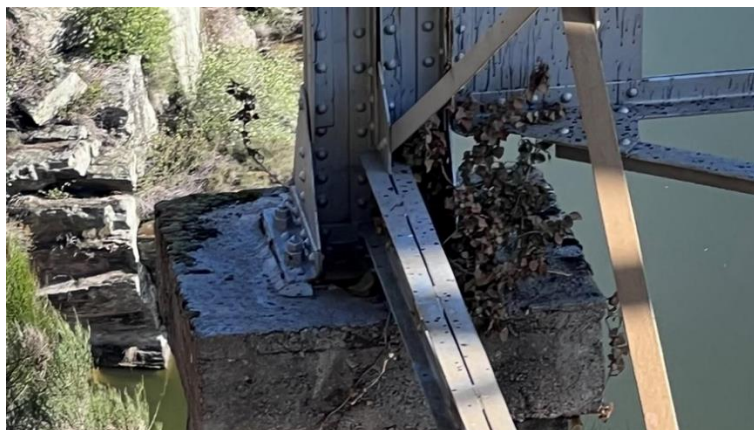
In some of the support cubes of the palisades, the presence of vegetation and organic matter, mainly moss, was located, being especially relevant in the sixth palisade, close to the second abutment (Fig. 13). The presence of vegetation on the concrete elements always denotes maintenance that can be improved. The deterioration of concrete caused by plants is still a chemical attack induced by living organisms. In the case of superior plants, this effect combines a mechanical and chemical action, since the roots generate pressure on the joints or cracks where the plant roots and, at the same time, retain moisture, which intensifies the damage.

Fig. 13. Presence of organic matter and vegetation in the concrete support die of palisade 6, downstream side (photograph by the author, taken with a drone).

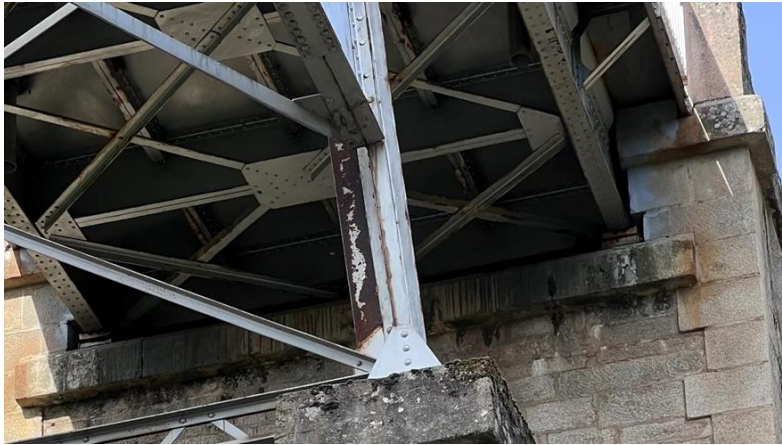
The palisades showed, in a generalized way, the deterioration of the protection system against corrosion. In this sense, it was found that the damage was aggravated in the palisades at the ends: in the first palisade, on the downstream side, and in the seventh palisade, also on the downstream side (Fig. 14).

Fig. 14. Corrosion in palisade number 7, the closest to the second abutment, downstream side (photograph by the author, taken with a drone).

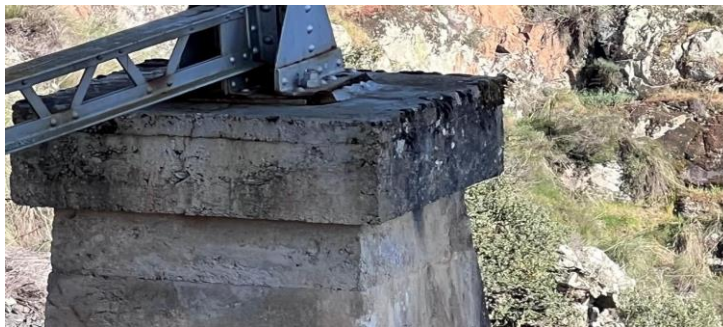
In the case of the last palisade, the seventh palisade, the drone made it possible to discover the loss of the head in one of the anchor bars, in the downstream support (Fig. 15). This loss seemed to be also linked to the corrosion existing in the bar, which must have finally caused it to break.

Fig. 15. Loss of one of the anchor heads in palisade 7, downstream side (photograph by author, taken with drone).

Another additional damage, as a result of the existence of corrosion, is the loss of the head of one of the four anchor bars of the last palisade at its downstream end.

The damage observed does not jeopardize the current functionality of the structure, but due to the aging of the existing corrosion protection system and the localized existence of corrosion that has already caused the loss of section and breakage of some components, the renewal of the corrosion protection system is considered appropriate and necessary. repairing and sealing those points where there is a loss of section, and renewing the anchor bar of the last palisade.

Based on what has been observed, it is considered appropriate to provide the structure with a new protection system that provides corrosion protection for at least another 25 years, after punctual repair of the defects and/or deterioration observed, paying special attention and detail to the cleaning and adaptation of those areas with corrosion and providing the new protection system with an adequate support base to prevent its loss or failure before its useful life. In other words, preventive actions are proposed, on the one hand, in order to prevent the advance of corrosion and the consequent deterioration of the metal elements; and, on the other hand, palliative actions, surface repair of some metal elements, such as the installation of a new anchor bar in palisade 7 or the replacement of stiffeners in railings.

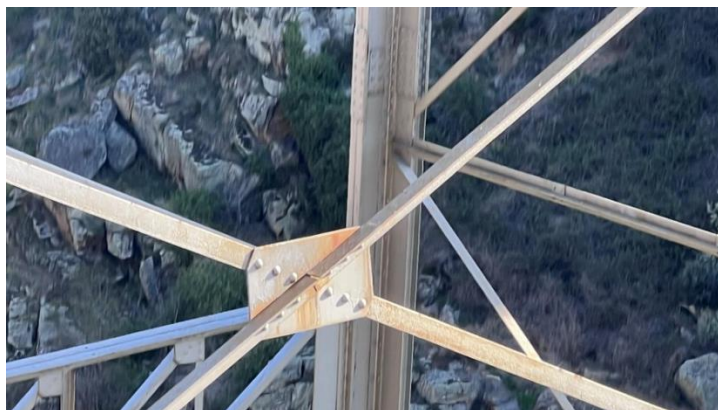
The analysis of the ends concluded with the detection of localized corrosion in some of the braces, this being more pronounced in the area of the second abutment (Fig. 16). Undoubtedly, this deterioration is a consequence of the combined action of oxygen and humidity in the environment, as the metal elements lack an adequate surface treatment for protection.

Fig. 16. Corrosion located in one of the braces of the palisade at the west end of the Bridge, upstream side (photograph by the author, taken with drone).

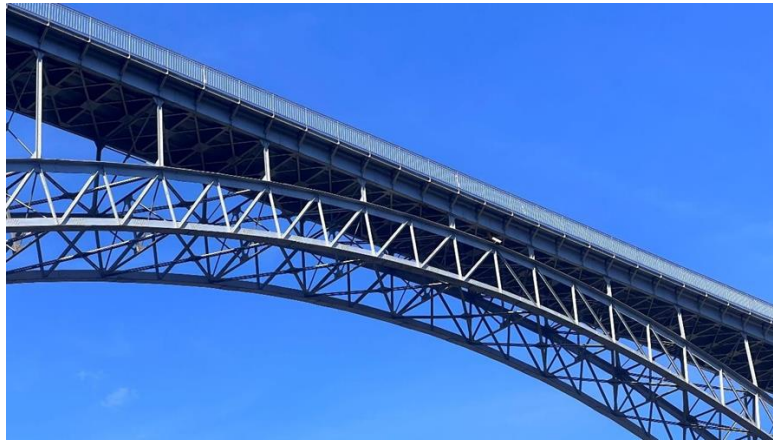
Fig. 17. Bottom view of the arch, from the downstream side (photograph by the author, taken with a drone).

It was also possible to observe patinas produced by the discharge of water and other liquids through the drainage pipes, which at the time of the visit were not long enough to facilitate the discharge away from the arch (a tube in the center of the arch can be seen in Fig. 7 and in Fig.

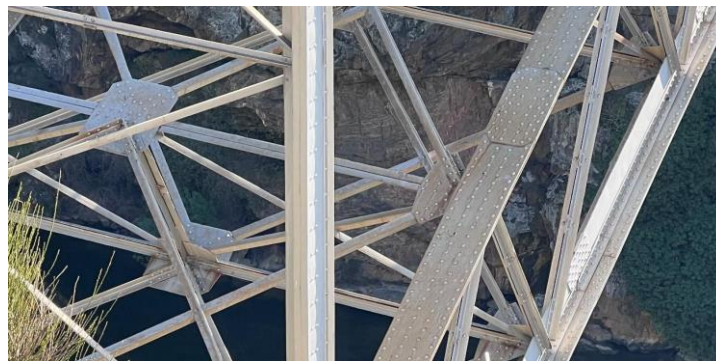
During the inspection, it was found that the arch only showed deterioration due to the aging of the anti-corrosion protection system (Fig. 18), showing dots with rust patinas on the upper part of the head of the side beams that make up the arch, as well as point rust in areas where the pieces are joined (Fig. 19).

Fig. 18. General condition of the arch, in a section between support uprights (photograph by the author, taken with a drone).

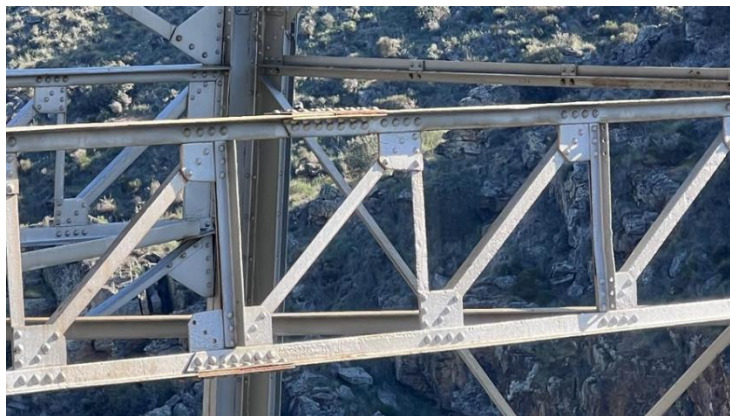
Fig. 19. Detail of a section of the arch, with spot corrosion located in the joint areas (photograph by the author, taken with a drone).

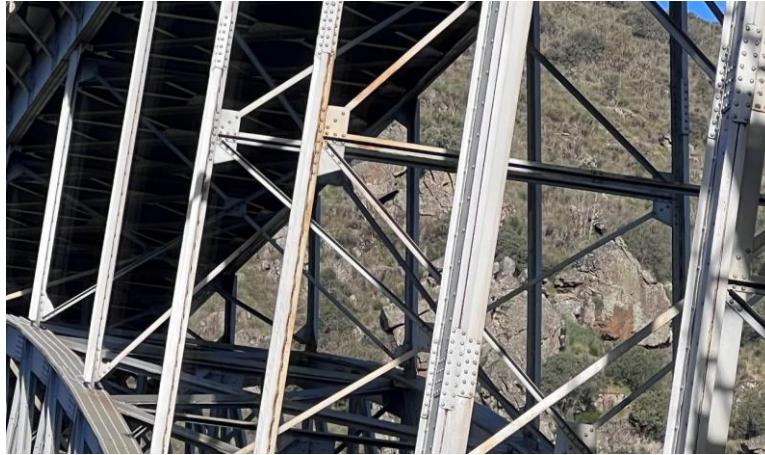
On the other hand, the uprights on the arch did show deterioration of the protection system against corrosion due to ageing in a generalised way. So much so, that corrosion points could be observed between elements that made up the upright, such as the sheets and L-profiles (Fig. 20).

Fig. 20. Detail of corrosion in one of the uprights above the arch (photograph by the author, taken with a drone).

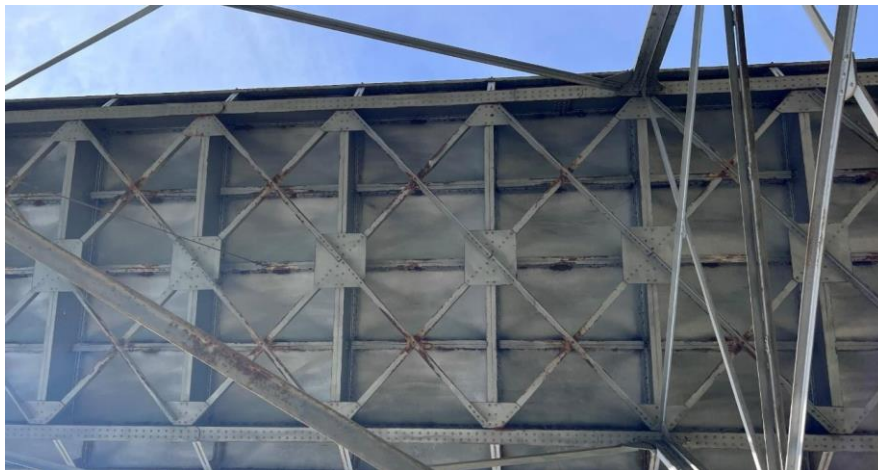
Crowning the arch was the deck, which also shows localized corrosion at extended points along its entire length and width (Fig. 21).

Fig. 21. View from the underside of a section of the deck, where a multitude of elements with symptoms of localized corrosion can be seen (photograph by the author, taken with a drone).

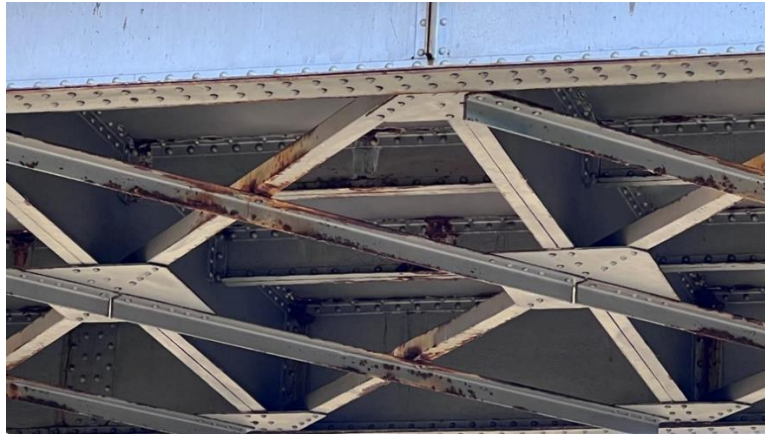
A more detailed view shows that the corrosive action is especially located in the joints between the beams and the slab and transverse beams, as well as in the joints of the crosses of San Andrés of the horizontal bracing (Fig. 22).

Fig. 22. Detailed view of a section of the deck, where localized corrosion of several elements can be observed (photograph by the author, taken with a drone).

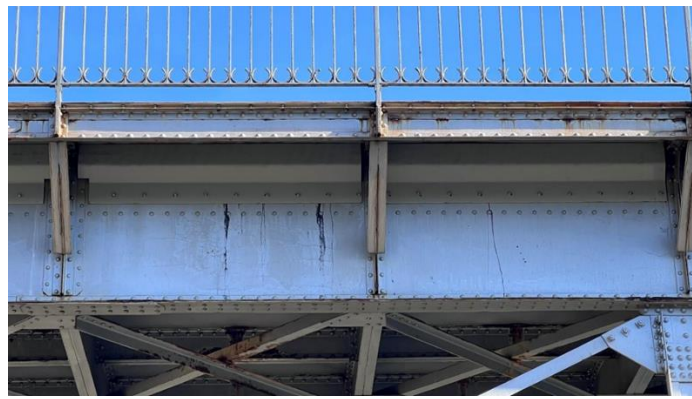
As a culmination of the analysis of the deck, the cantilevers formed by metal sheets that make up the sidewalks, and which were supported by metal corbels, were analyzed. As expected, the impost and all the other elements were not immune to the corrosive action (Fig. 23): in all of them there were traces of corrosion and traces of dyed runoff water.

Fig. 23. View of the impost and the lower part of the perimeter protection railing (photograph by the author, taken with a drone).

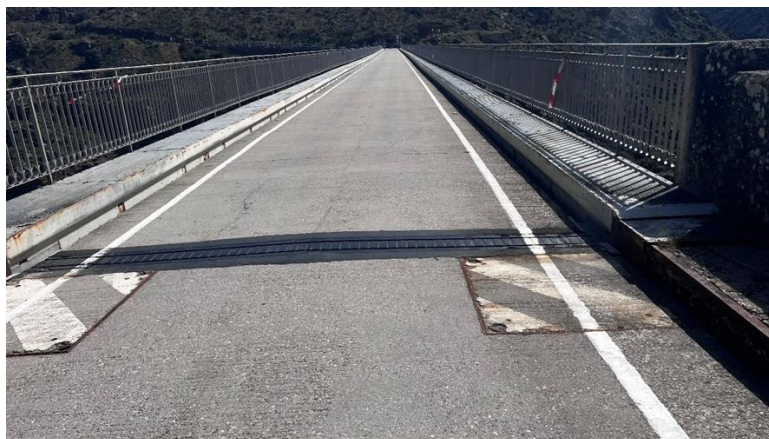
On the platform, the existence of corrosion on the railings and on the sidewalks could be observed (Fig. 24), as well as the localized deformation of the handrail of both railings, caused by the loss or theft of the cylindrical stiffeners, and occasionally to the loss of union of the crown cap.

Finally, a slight deterioration of the joints was also observed on the platform due to their ageing, as well as the corrosion of the existing metal beds on the four access sidewalks to the structure (Fig. 24).

Fig. 24. View of the overlying road platform, in image taken from the second abutment (photograph by the author).
