Vibration Analysis of Transformer as an Early Diagnosis of Internal Transformer Faults: (Case Study of Transformer #3 GIS Kemang)

Yuniar Rizky^{1,2}, Mohammad Adhitya^{1*}

¹Department of Mechanical Engineering, Faculty of Engineering, Universitas Indonesia, Depok, Indonesia

²Departement of Electrical Transmission Region West of Java, PT PLN Persero, Jakarta, Indonesia

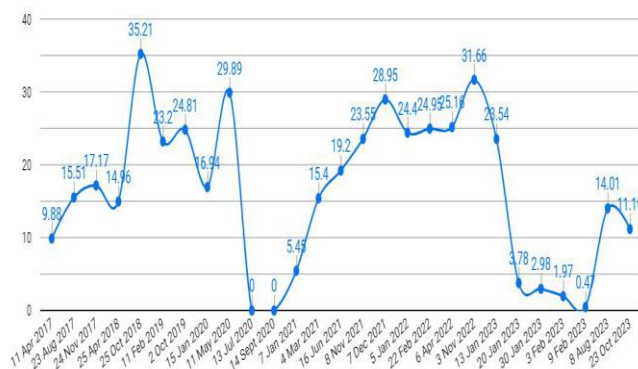
Figure 9. The Concentration of Acetylene (C₂H₂) in Bottom Maintank Transformer

The initial dissolved gas analysis (DGA) indicated an elevated concentration of acetylene (C₂H₂) in the transformer oil, particularly in the Maintank and tubular sections. Acetylene is typically produced at temperatures above 500°C and is strongly associated with electrical arcing within the transformer. The DGA results indicated that the insulation was probably under stress from arcing, necessitating more examination with Acoustic Emission sensors and strengthened by High-Frequency Current Transformer sensor.

The DGA results provided a strong indication that internal electrical discharges were occurring, justifying the need for more detailed partial discharge (PD) testing.

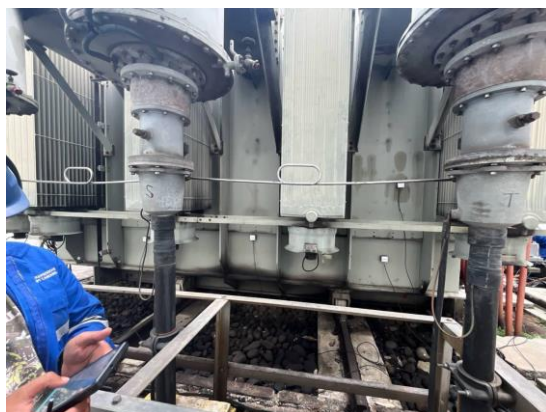
Figure 10. Installation of 4 AE Sensors

The high-frequency current transformer and acoustic emission sensors were deployed at multiple locations around the transformer. One significant PD source was identified at the high-voltage (HV)/tubular section.

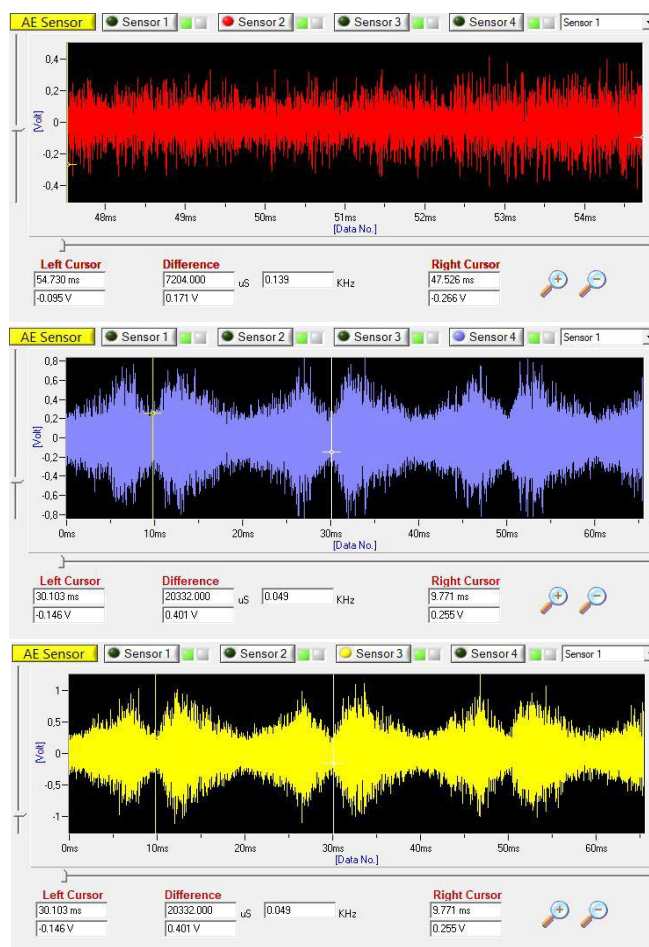
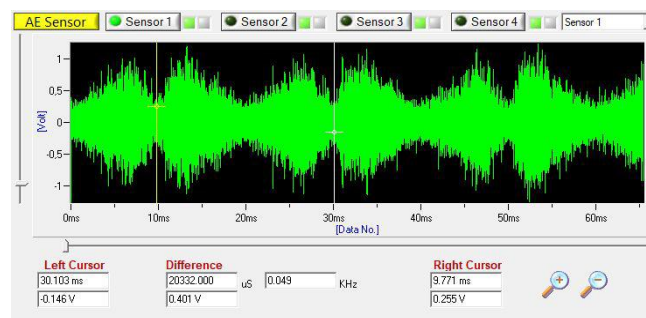
Figure 11. AE Measurements of Damaged Transformer

AE sensors positioned near the HV/tubular section detected repeated acoustic waveforms that indicated active PD. The sensors captured burst events with time intervals 20.332 milliseconds, which is consistent with high-level PD. However, the detected acoustic amplitudes were relatively high, the potential for insulation damage was significant.

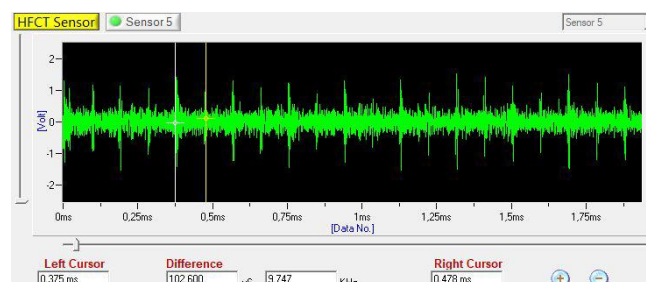
Figure 12. HFCT Measurements of Damaged Transformer

HFCT sensors confirmed the presence of high-frequency electrical signals corresponding to the burst events. The interval measurements between HFCT pulses were 0.102 milliseconds, further corroborating the AE data. As a comparison, a similar test was conducted on a healthy Transformer, Transformer #1 GIS Grogol with the same installation conditions, and the following results were obtained:

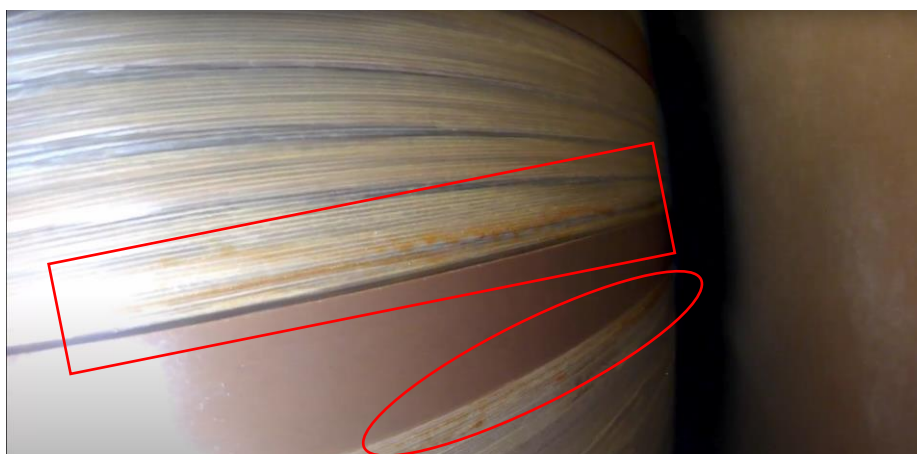
Figure 15. Spot Marks on the insulation paper of the HV Phase T Winding

This inspection confirmed the presence of discharge marks (treeing) on the Pertinax magnetic shunt, which corroborated the AE sensor data indicating insulation degradation. The visual examination also revealed spot marks on the insulation material surrounding the winding in the HV Phase T, further supporting the hypothesis that electrical stress was causing insulation breakdown.

However, the high amplitude of the acoustic signals suggests that the risk of further insulation degradation and failure increases over time if not addressed. The inside check provided additional evidence of significant stress in the HV/tubular section and moderate stress in the OLTC, indicating that the transformer is approaching the end of its operational life without significant intervention.
