# Effects of Vegetation and Soil Type on the Stability of the Marankiari Road Slope, Chanchamayo

The research article presents the results of a study aimed at understanding the effect of vegetation and soil type on the stability of road slopes in the province of Chanchamayo. The data and methods section includes tables showing in detail the analyses carried out in the Soil Mechanics laboratory for slope stability purposes, as well as graphs showing the safety factors and percentage increase in the safety factor considering vegetation independently to see their effects on each type of soil. In the results it was observed that both vegetation and soil type have a significant influence, profile 3 is already considered unstable in the analysis due to the type of soil alone, but if we apply vegetation such as Tillandsias in pseudostatic conditions the safety factor in relation to the initial value of soils increases by 16.36% while in static conditions the safety factor does not increase significantly since it is the most critical profile unlike profile 1 in which in static and pseudostatic conditions with Albizia carbonaria vegetation the percentage increases by 8.35% and 11.14%; and

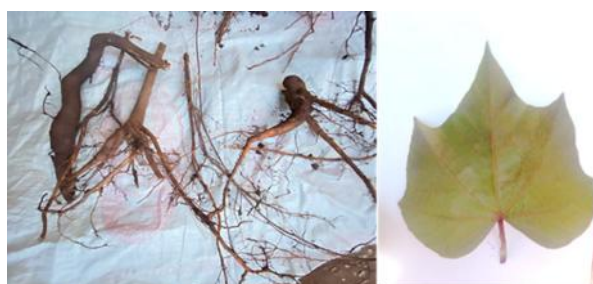
**Figure 4** Ohrima pyramidal

Note: Native vegetation *Ochroma pyramidale* commonly called Huampo Negro. This vegetation has a type of radial root that can grow up to 30 meters with a life span of 7 years. The *Ochroma pyramidale* is located in the three profiles of the study, but is mainly found in the section of profile 2 (km 16+718 to km 16+817).

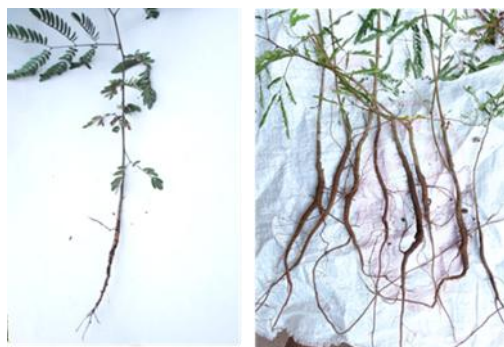
**Figure 5** *Albizia carbonaria*

Note. Native vegetation *Albizia Carbonaria* commonly called Albizia . This vegetation has a type of taproot that can grow up to 25 metres with a life span of 30 years. *Albizia Carbonaria* is located mainly in the lower and central part within the sections of profile 2 (km 16+718 to km 16+817) and profile 3 (km 16+817 to km 16+926).
