Use of RPAS (Drones) for the Inspection of Century-Old Metal Structures: Example of Application on the Requejo Bridge

Rodríguez Elizalde, Rubén (*)

This article presents a technical analysis of the Requejo Bridge, an outstanding example of metallic engineering spanning the Duero River in Zamora, Spain.

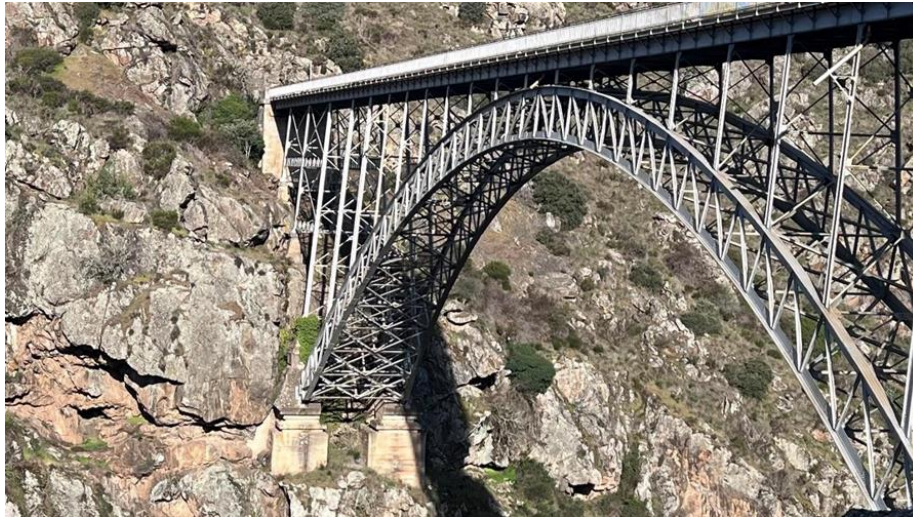
Fig. 7. Partial view of the Bridge, from the south side (upstream side), where you can see the constitutive arch and, in the background, the second abutment, with its corresponding support palisades (photograph by the author, taken with a drone).

It was also possible to observe patinas produced by the discharge of water and other liquids through the drainage pipes, which at the time of the visit were not long enough to facilitate the discharge away from the arch (a tube in the center of the arch can be seen in Fig. 7 and in Fig.

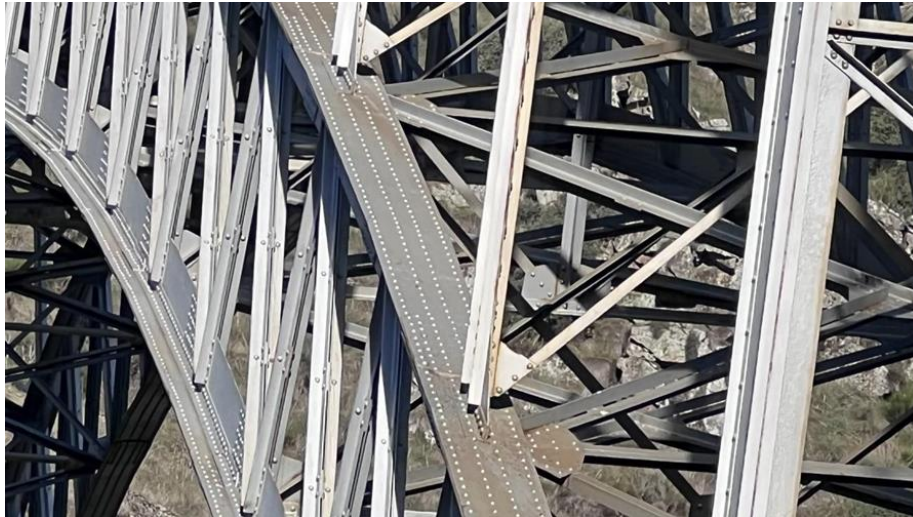
The uprights are supported on the arch by means of platforms anchored with bolts to the main beams of the arch (Fig. 9). This arch has a span of 120 m between supports, being a lowered arch with an arrow of 23.42 m (Fig. 4) and, as already noted, having a height above the sheet of water of the River of 90 m. The arch varies its section from the supports, where it has a maximum width of 8.30 m, to the centre of the span, where the maximum width is reduced to 4.50 m, also having a slope of 1:12 in both elevations of the arch.

Fig. 9. Examples of upright supports on the arch, through platforms anchored with bolts, on the upstream side (photograph by the author, taken with drone).
