Vibration Analysis of Transformer as an Early Diagnosis of Internal Transformer Faults: (Case Study of Transformer #3 GIS Kemang)

Yuniar Rizky^{1,2}, Mohammad Adhitya^{1*}

¹Department of Mechanical Engineering, Faculty of Engineering, Universitas Indonesia, Depok, Indonesia

²Departement of Electrical Transmission Region West of Java, PT PLN Persero, Jakarta, Indonesia

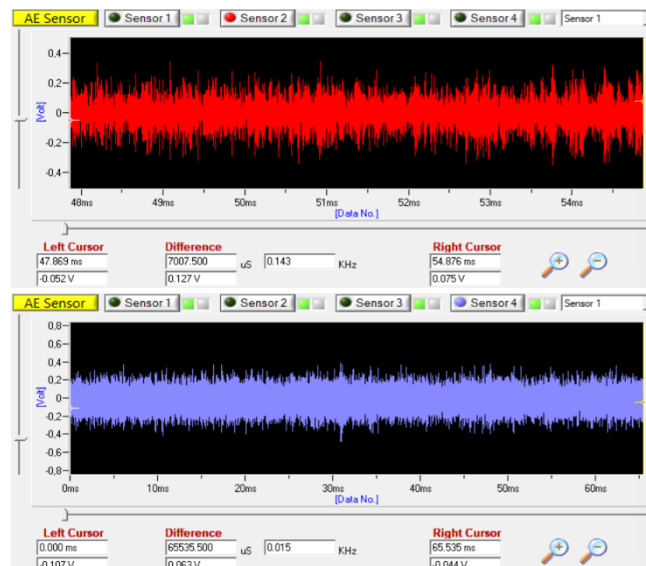
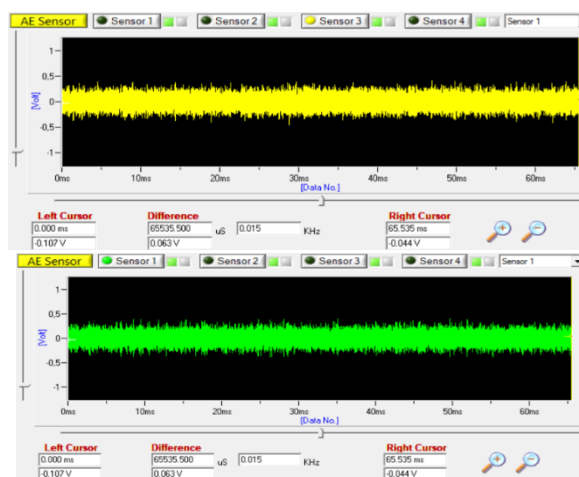
Figure 13. AE Measurements of Healthy Transformer

From the recorded waveform, a significant difference can be observed. The waveform results from the damaged transformer (Transformer #3 GIS Kemang), which are on the same scale, display a repeating butterfly-shaped pattern, whereas the healthy transformer (Transformer #1 GIS Grogol) shows no waveform formation, only a steady signal at a consistent amplitude.

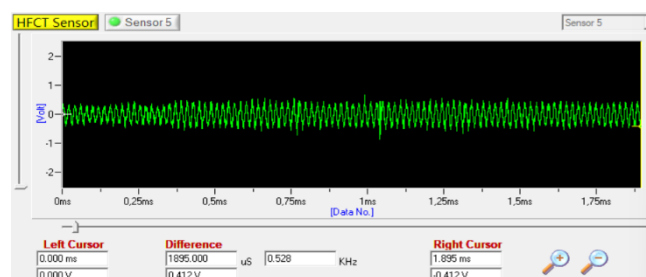
Figure 14. HFCT Measurements of Healthy Transformer

Similarly, in the HFCT sensor measurements, no burst waveforms were found in the healthy transformer, unlike those detected in the damaged transformer.
